# GRACE MINE TAILINGS DAM

NDI-PA 00715  
PA DER 6-445

PHASE I INSPECTION REPORT  
NATIONAL DAM INSPECTION PROGRAM

Name of Dam: Grace Mine Tailings Dam - ID # PA 00715  
State Located: Pennsylvania  
County Located: Berks  
Stream: Tributary to Hay Creek  
Coordinates: Latitude 40° 11.3' Longitude 75° 52.1'  
Date of Inspection: May 15, 1979

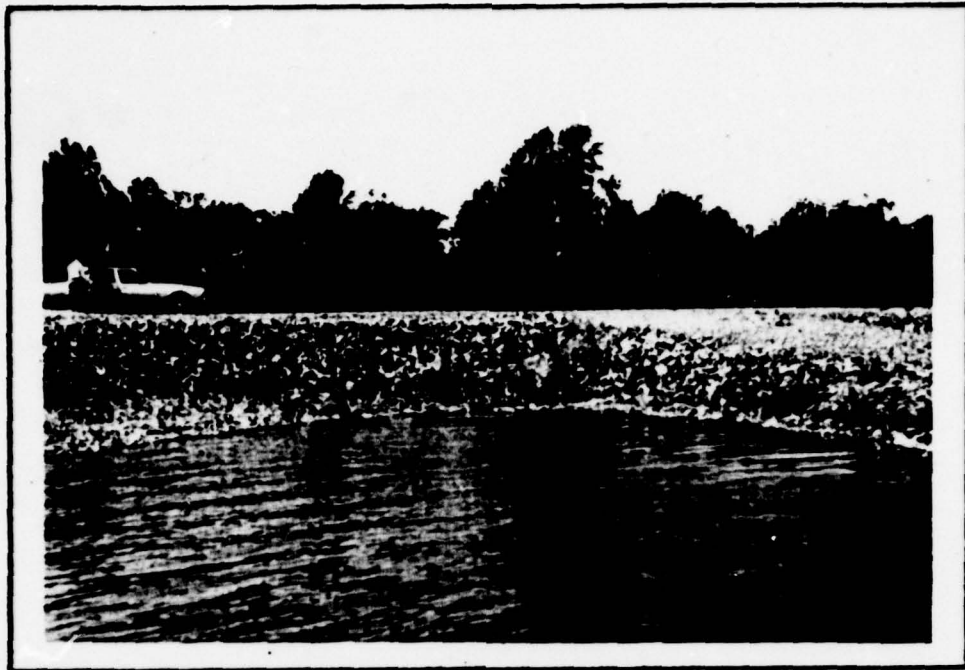
c. Appurtenant Structures. The spillway section is a rock filled channel that is difficult to differentiate from the remainder of the structure on the basis of surface appearance. The condition of the spillway crest and side walls could not be determined. There is no outlet channel provided for the spillway.

The spillway is designed to release any reservoir surcharge through a controlled process by permitting the water to discharge slowly through interstices of the rock used to fill the spillway opening.

*VIEW OF THE ROCK FILLED SPILLWAY SECTION  
NEAR THE LEFT ABUTMENT*

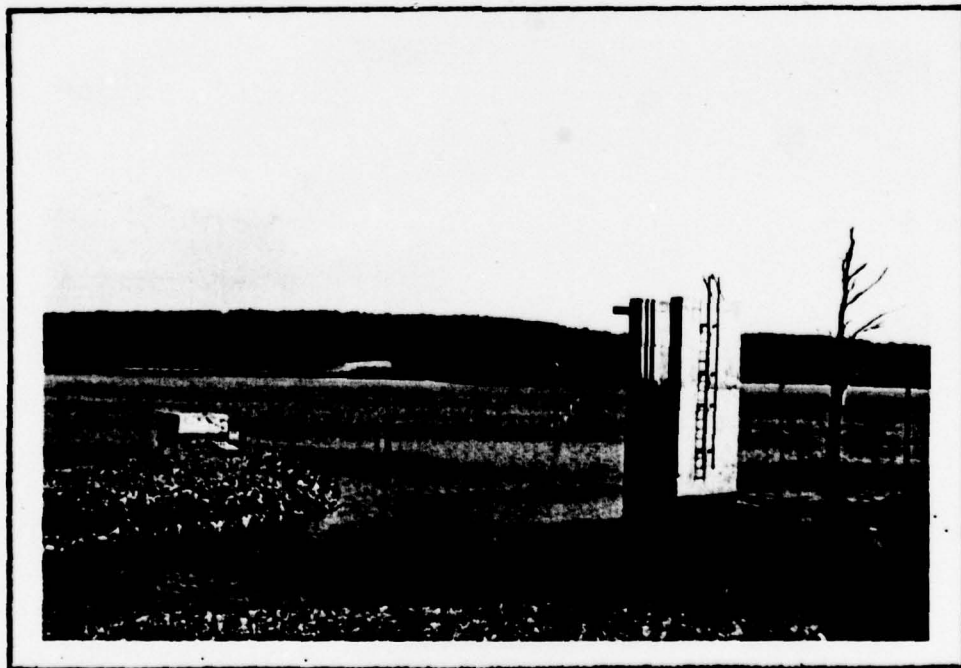
The first three decants were completely submerged on the date of the inspection. The water level was near the top of decant #4 and approximately 1.7 feet below the crest of decant #5. Both decants appeared to be in good condition. The connecting pipe extends beyond decant #5 and above the water surface to natural ground on the left abutment. The outlet pipe was discharging a small amount of flow (0.1 cfs) into the outlet structure during the inspection. The outlet structure is a rectangular concrete box, approximately 10 feet by 12 feet, which releases the flow through a Parshall flume and into the downstream channel. An additional Parshall flume is located in the channel downstream, but it is in a state of disrepair. Some discharge (0.15 cfs) was observed from the outlet end of a 12-inch diameter spring drain pipe which protrudes from the right abutment approximately 70 feet from the outlet structure. Water was also observed flowing down the left abutment slope and into the downstream channel.

The visible portions of decants #4 and #5 appear to be in good condition and show no signs of structural instability.

*DECANT #4 (NEARLY SUBMERGED) AND DECANT #5  
NEAR THE LEFT ABUTMENT*

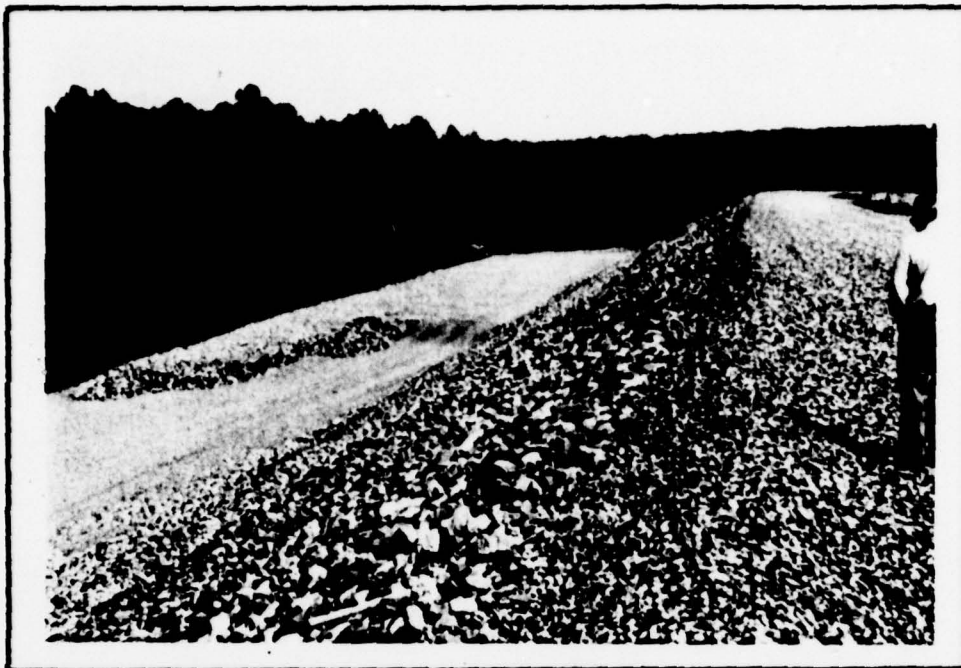
b. Dam. The downstream slope of the embankment appears to be consistent with the design drawing slope of 1.75H:1V. The slope is composed of rockfill, has an 80-foot wide berm at elevation 540 and appears to be in good condition. The visible portion of the upstream slope also appears to be in good condition. The rockfill material on the surface of the dam appears to be well graded.

*TOP PORTION OF THE DOWNSTREAM SLOPE  
AND THE DOWNSTREAM BERM*

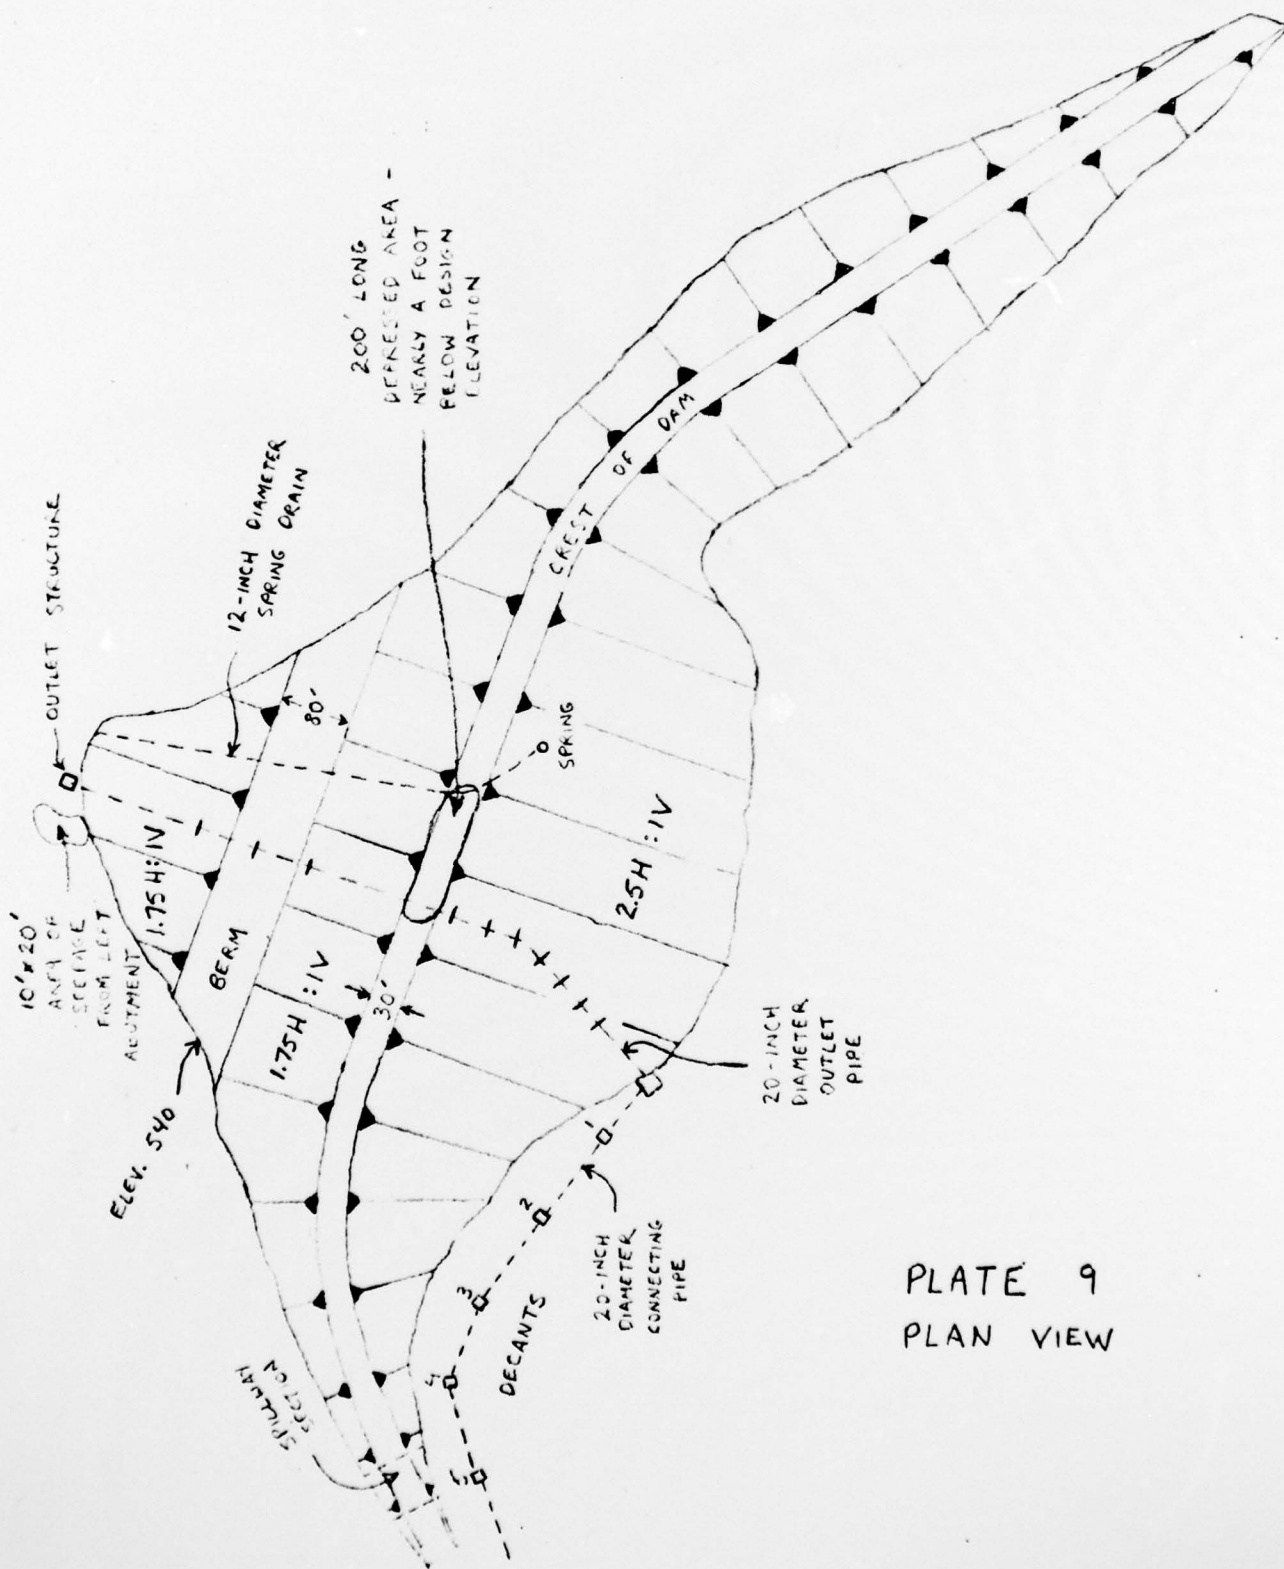
PLATE 9  
PLAN VIEW

a. Safety. The visual observations and review of available information indicate that Grace Mine Tailings Dam is in good condition. The survey of the crest of the dam revealed that an area near the longitudinal center of the embankment has settled nearly a foot below design elevation. However, the reservoir is capable of containing the Probable Maximum Flood with no discharge and without the low point on the crest of the dam being overtopped. Seepage from the left abutment near the outlet structure was observed during the inspection. The exact source of the seepage could not be determined although a natural spring seems to be the most probable cause.

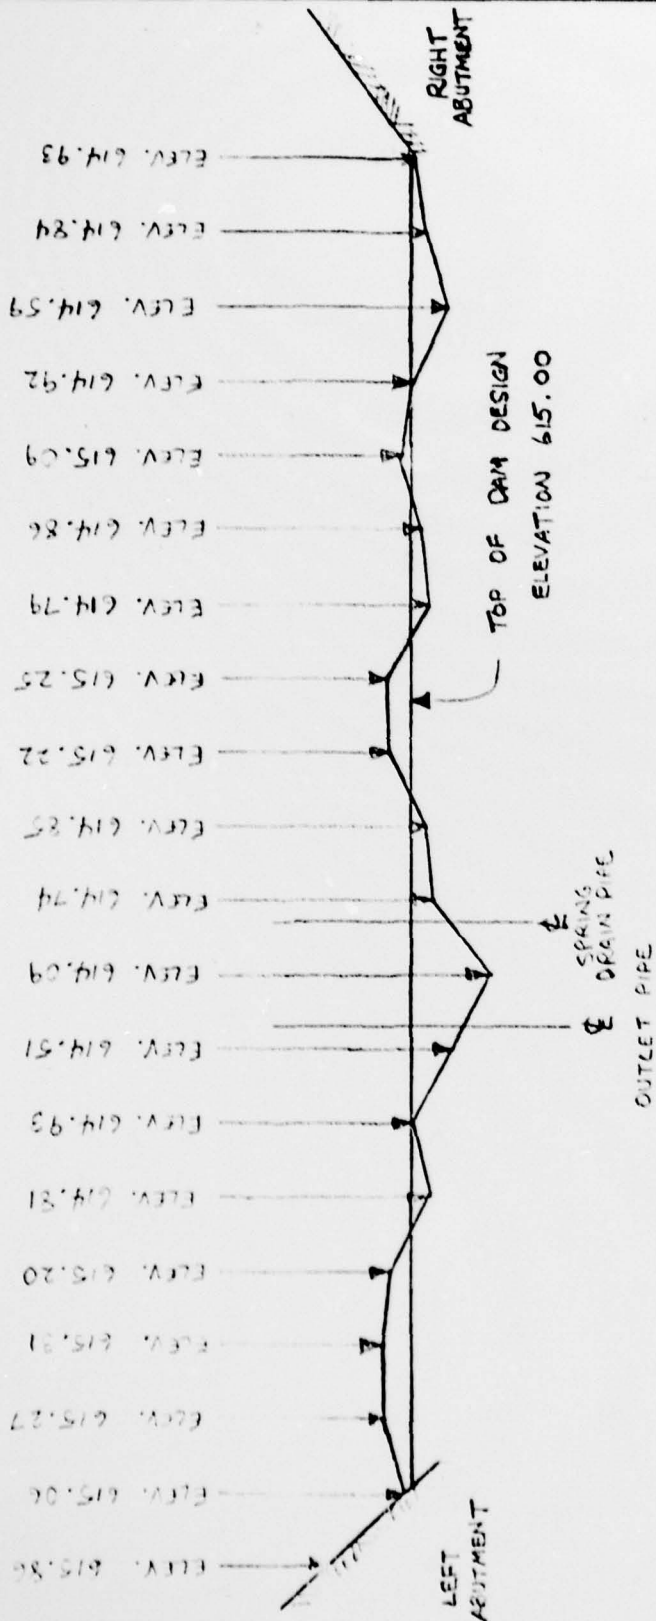
PLATE 10  
TOP OF DAM PROFILE  
LOOKING DOWNSTREAM

The survey of the crest of the dam revealed variations in elevation of more than a foot (refer to Plate 10, Appendix E). A depressed area located in the vicinity of the outlet pipe centerline was surveyed as nearly a foot below design elevation.

1. The top of the dam should be restored to design elevation with suitable compacted material. Surface monuments should be installed to monitor any future settlement of the top of the dam.
2. The seepage observed at the left abutment should be monitored. If any substantial increases in flow or migration of fines are noted, then a drainage pipe should be provided for this seepage to insure that the integrity of the embankment is not endangered.
